Document Title:	2020 Concrete Breakwater – Moorings – Completion Report
Document No.:	UCL – 2020.01 – REP001 – V1
	Prepared for Chaffers Marina Limited

Document title: 2020 Concrete Breakwater – Moorings – Completion Report

Document no.: UCL – 2020.01 – REP001 – V1

Document release: Released for Client review and comment - 10th February 2020

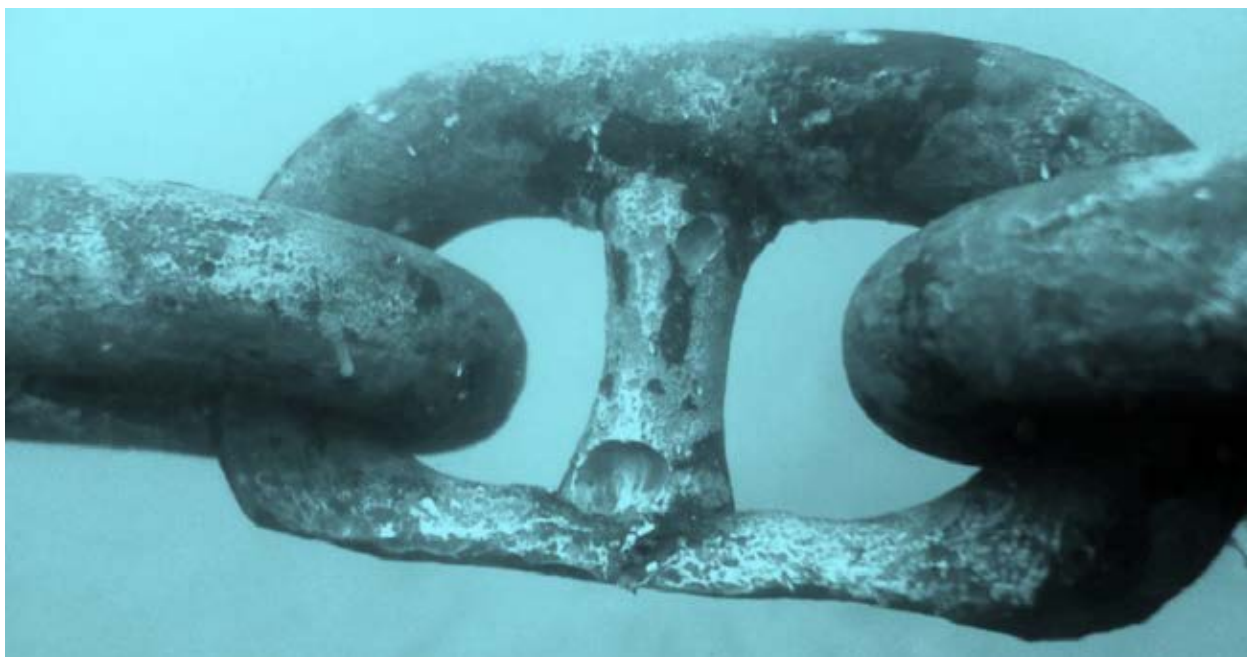
Figure 9: Example of a chain link located in the Thrash Zone – wear and corrosion are clearly evident. The irregular shape caused by wear and corrosion has resulted in cracking adjacent to the stud

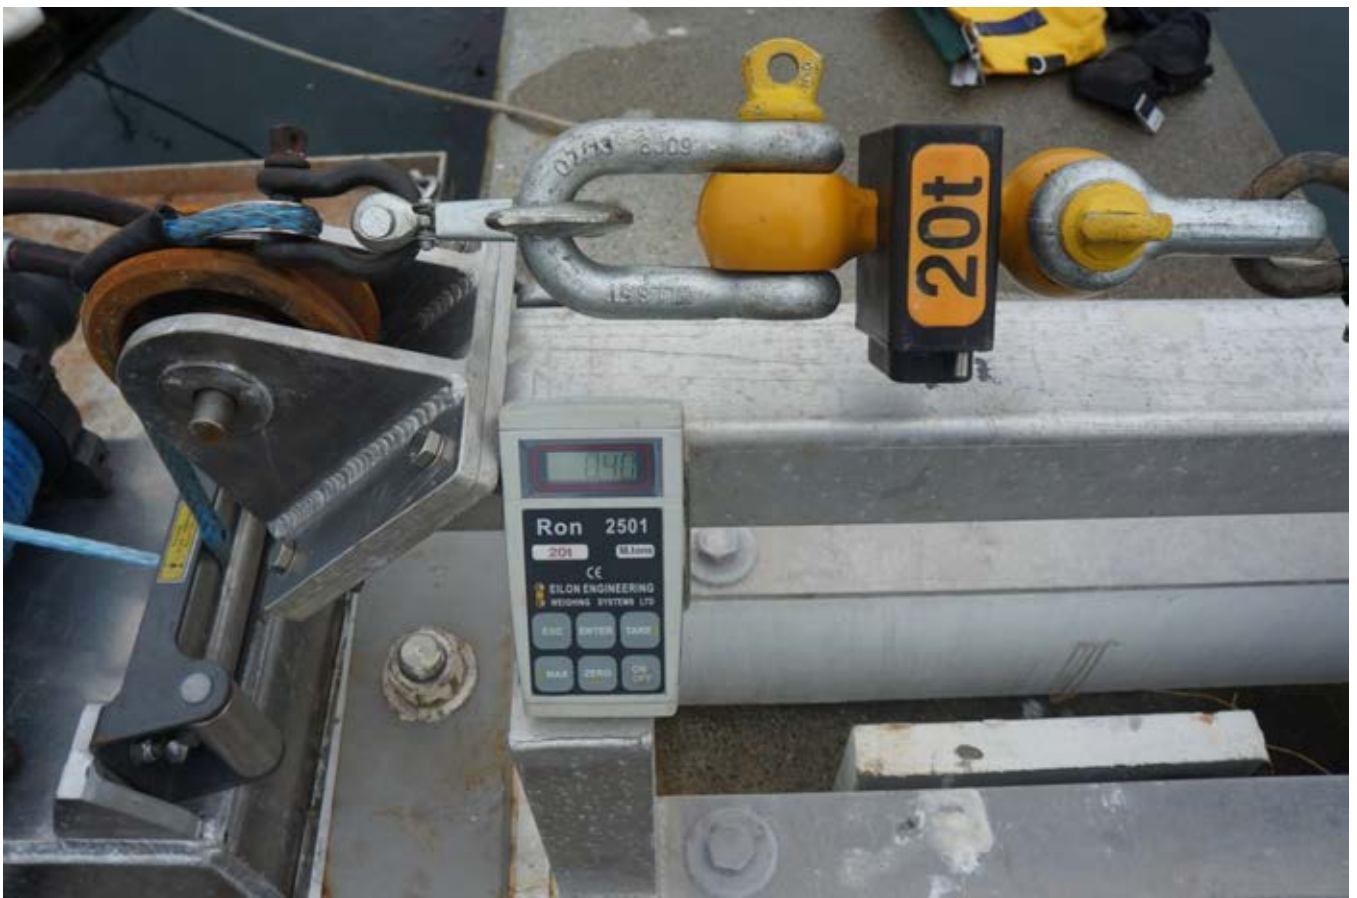
Figure 13: A pretension of 0.40 M.tons achieved the correct catenary angle on mooring chains
 Angle of chain at top connection to horizontal = 54° (approximate: BW at rest, however tidal influenced)
 Angle of chain at top connection to vertical = 36° (approximate: BW at rest, however tidal influenced)

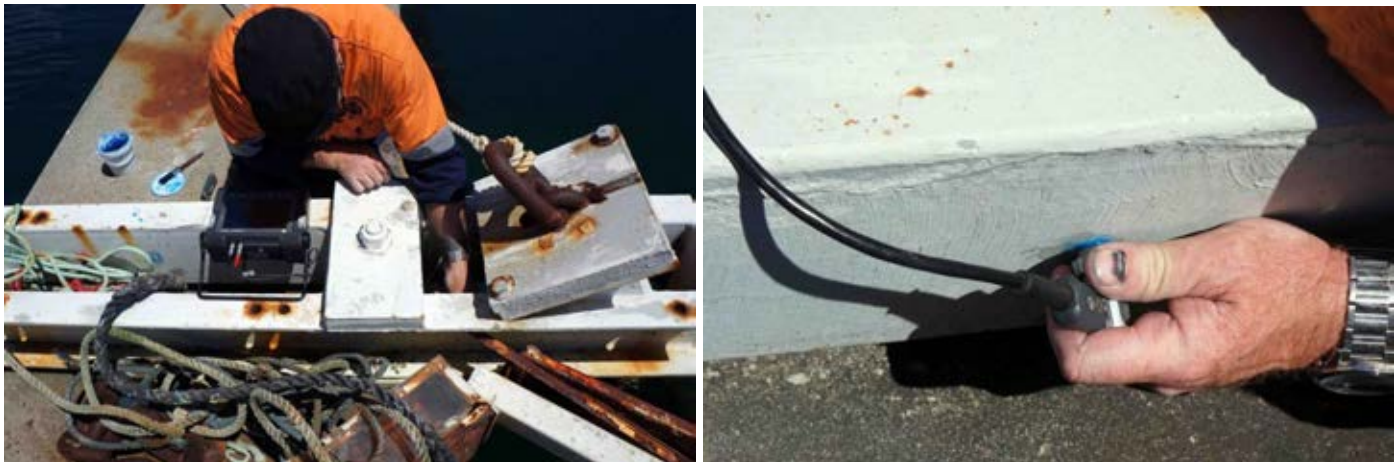
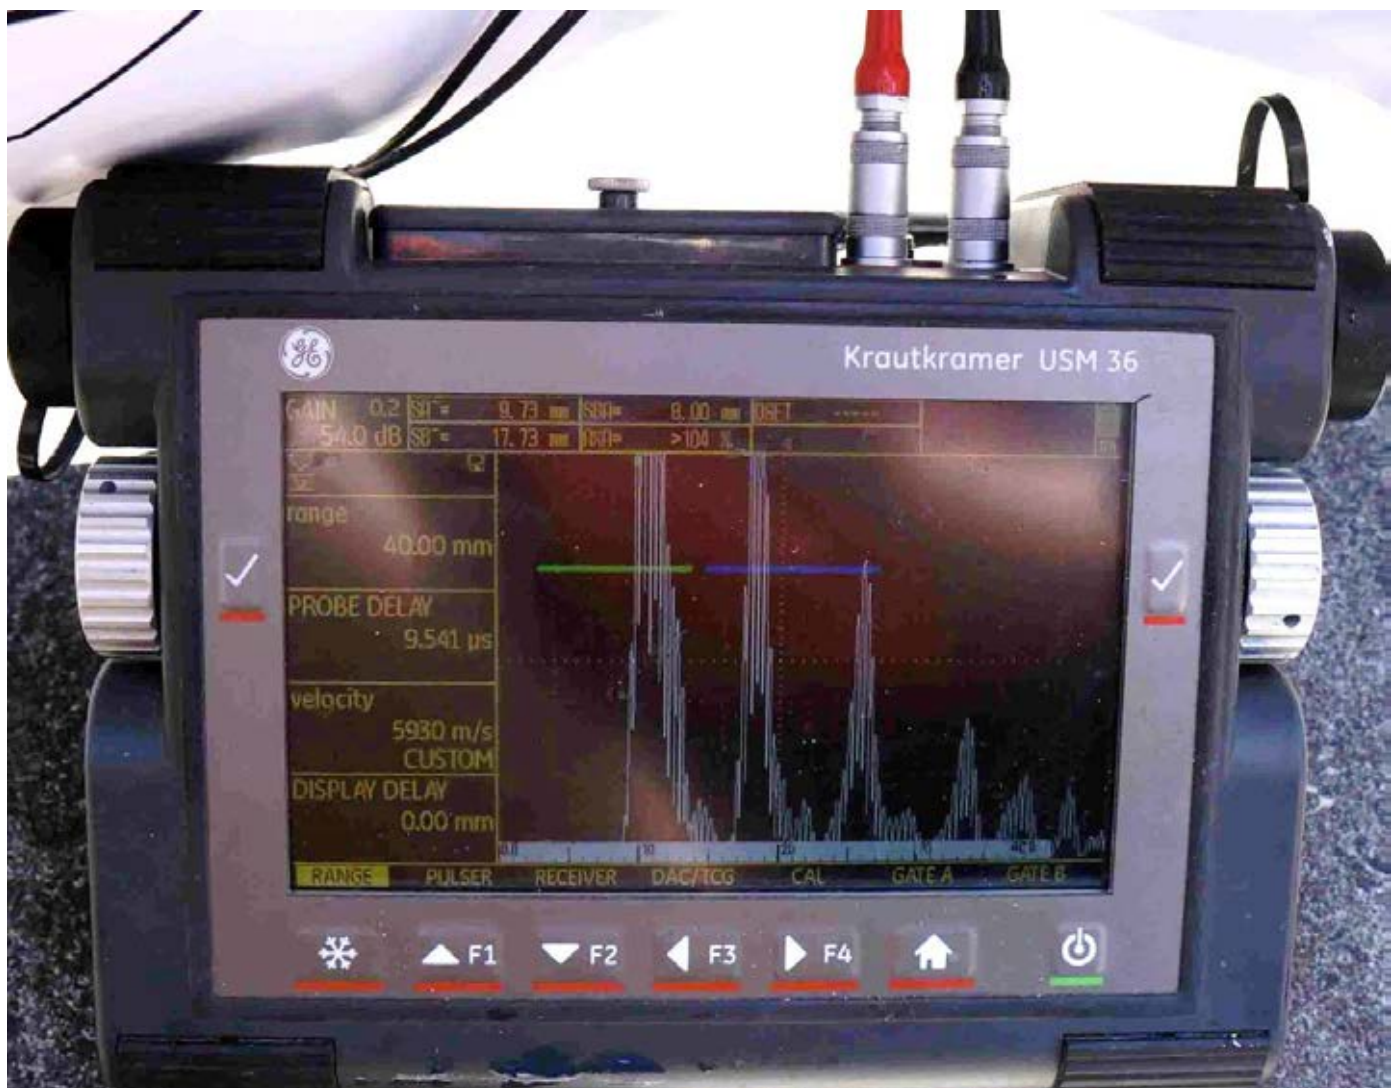
- Non-destructive testing (NDT) Ultrasonic Thickness Measurement (UTM) was carried out on all Anchorpoints to measure for loss of steel thickness.
- Where reduction in steel thicknesses (due to corrosion) were found to be greater than 40% of that of the original steel member design thickness, stiffening plates were weld installed to both strengthen the position and also improve the overall current structure integrity of the Anchorpoint.
- Rust descale, and protective paint coating application is currently in progress.

Figures 16, 17 & 18: Krautkramer USM 36 in operation – taking Anchorpoint PFC web thicknesses

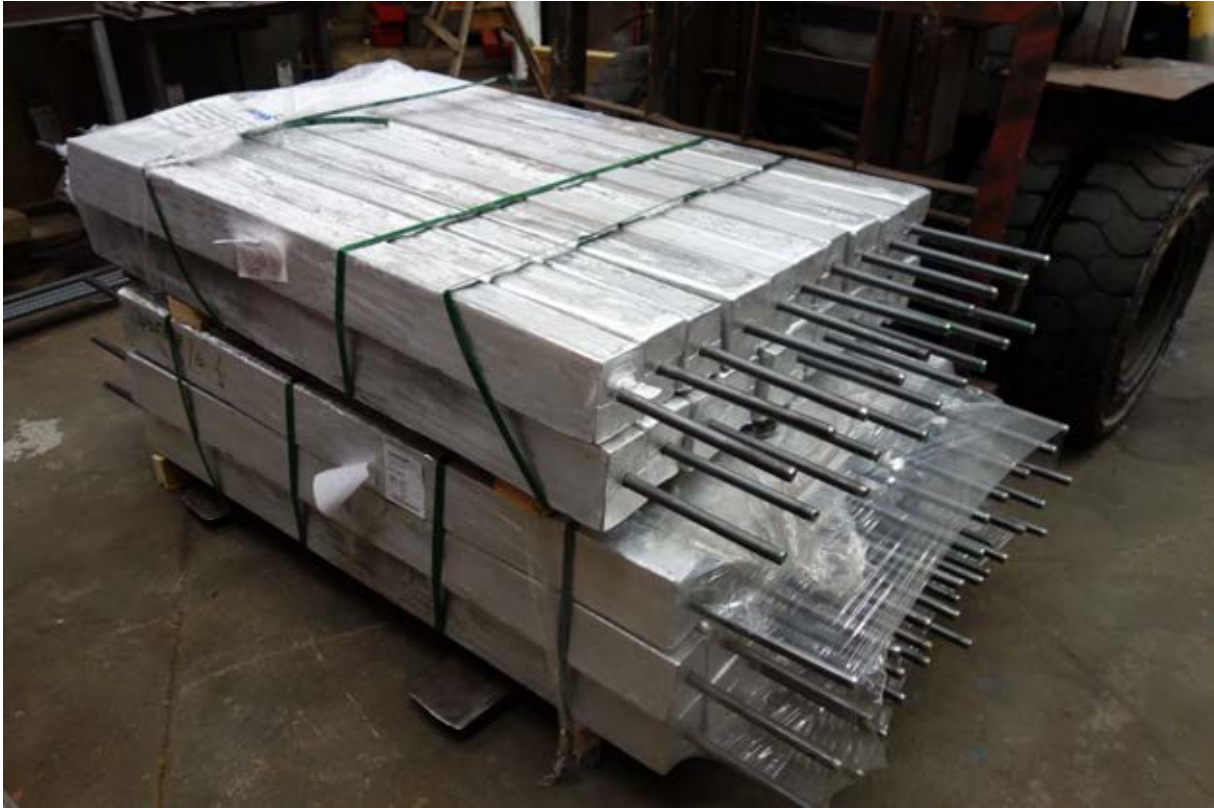
Figure 20: A50 (50kg ea.) sacrificial anodes

- A50 (50kg ea.) sacrificial anodes and bond cables have been installed and cathodic potential testing completed: connected to all top-end catenary chains to protect against corrosion.

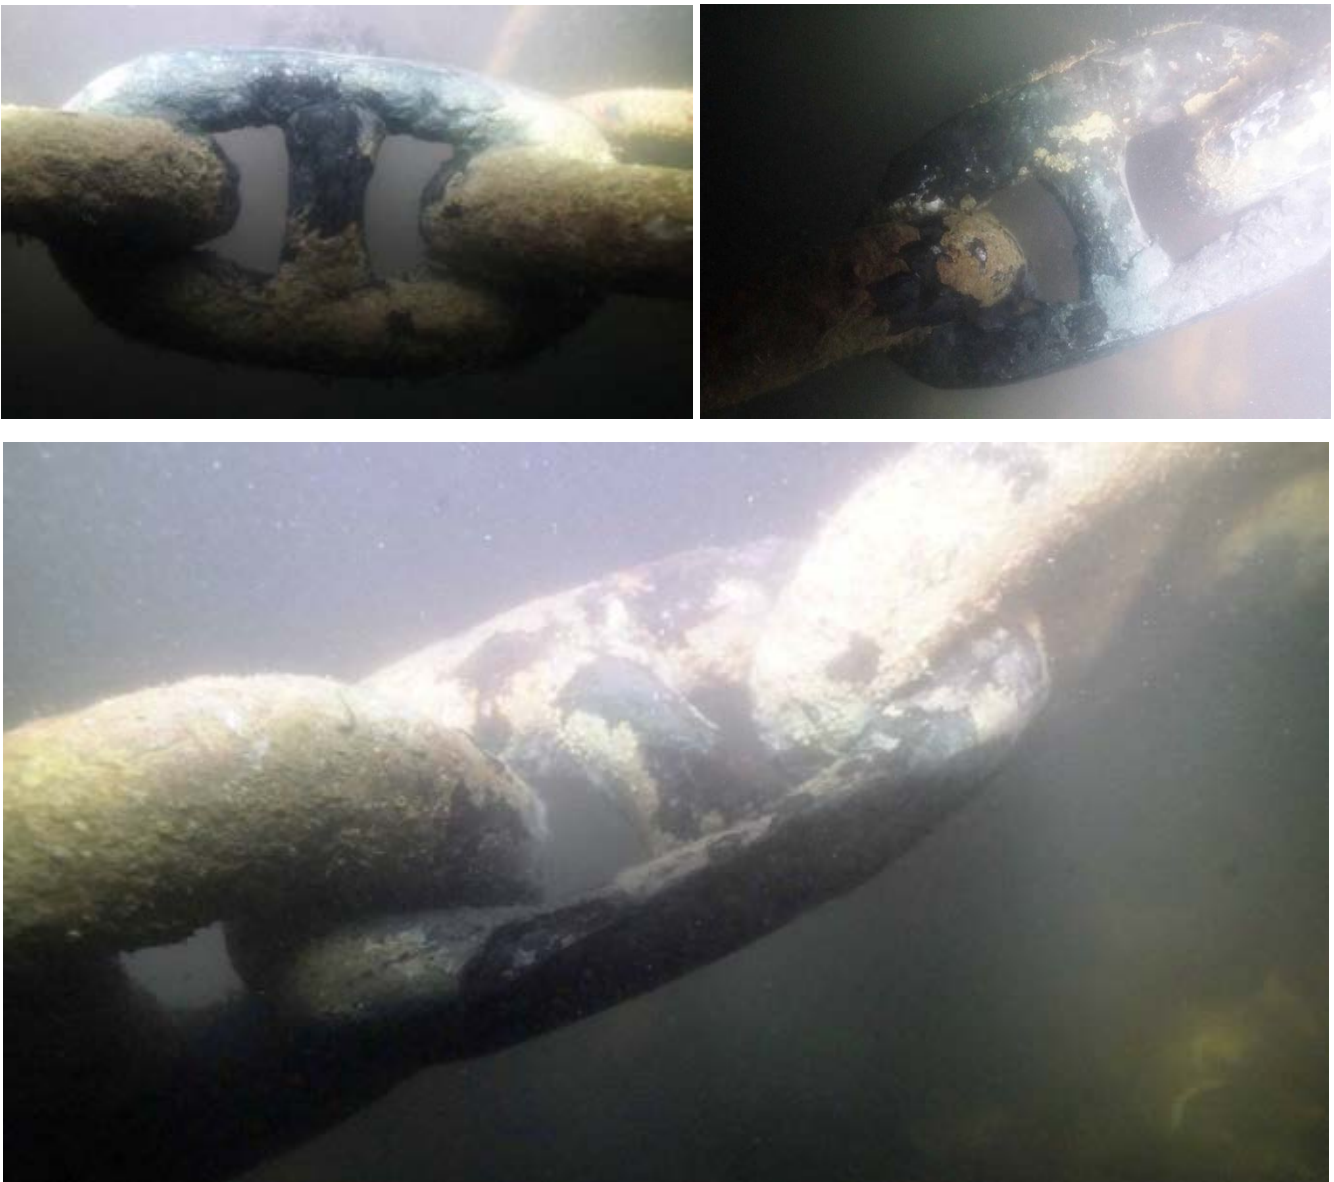
While engaged in the installation of the 6 new south-leading catenary chains it was observed that several of the ground chain (buried in seabed) sections exhibited excessive wear in many of their chain links.

This has meant slightly greater pretensions have needed to be applied in an effort to achieve catenary connection into a suitable chain link.

Figures 22, 23 & 24: South-leading ground chain – temporarily elevated out of seabed with use of a Lift-bag. It's believed that due to dredging when the OPT was operating, the seabed was reduced down to where a tight bound sedimentary layer of shell and stone composition now immediately underlies the current shallow mud and silt layer. This material is proving to be quite aggressive on the mooring chains within and beyond the thrash zone. With the correct pretension now being applied to the moorings, and subsequently minimised movement in Station, the affected zone should be significantly reduced

It's recommended that budget be brought forward to allow renewal procurement and installation to replace the existing 6 south-leading ground chain lengths within the 2020 – 21 financial year.
