Document Title:	Timber Pile Rehabilitation – FRP Sleeving – Completion Report
Document No.:	UCL – 2019.12 – REP001 – V1
	Prepared for Chaffers Marina Limited

Document release: Released for Client review and comment - 17th February 2020

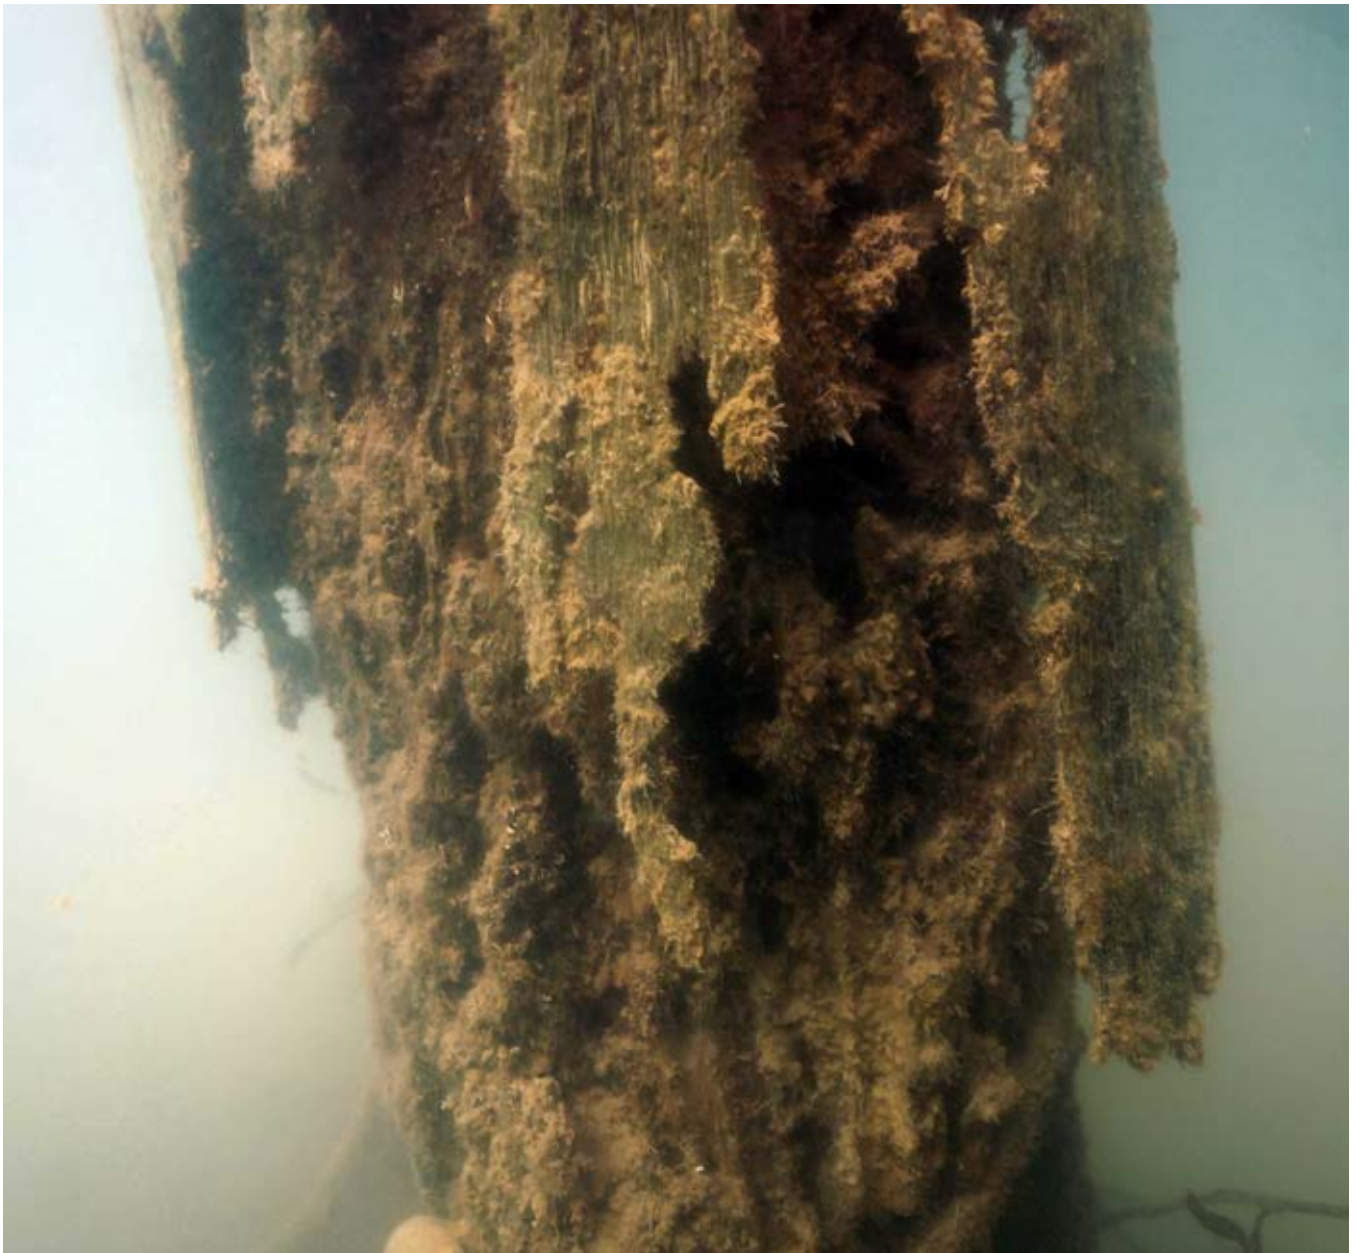
The major cause of pile deterioration within Chaffers Marina results from marine borer infestation of the timbers; predominantly from the ‘Sea Gribble – *Limnoria*’; and to a lesser extent ‘Ships Worm – *Teredo*’.

Figure 1: *'Pinus Radiata'* timber pile exhibits clear evidence of *'Limnoria'* borer damage

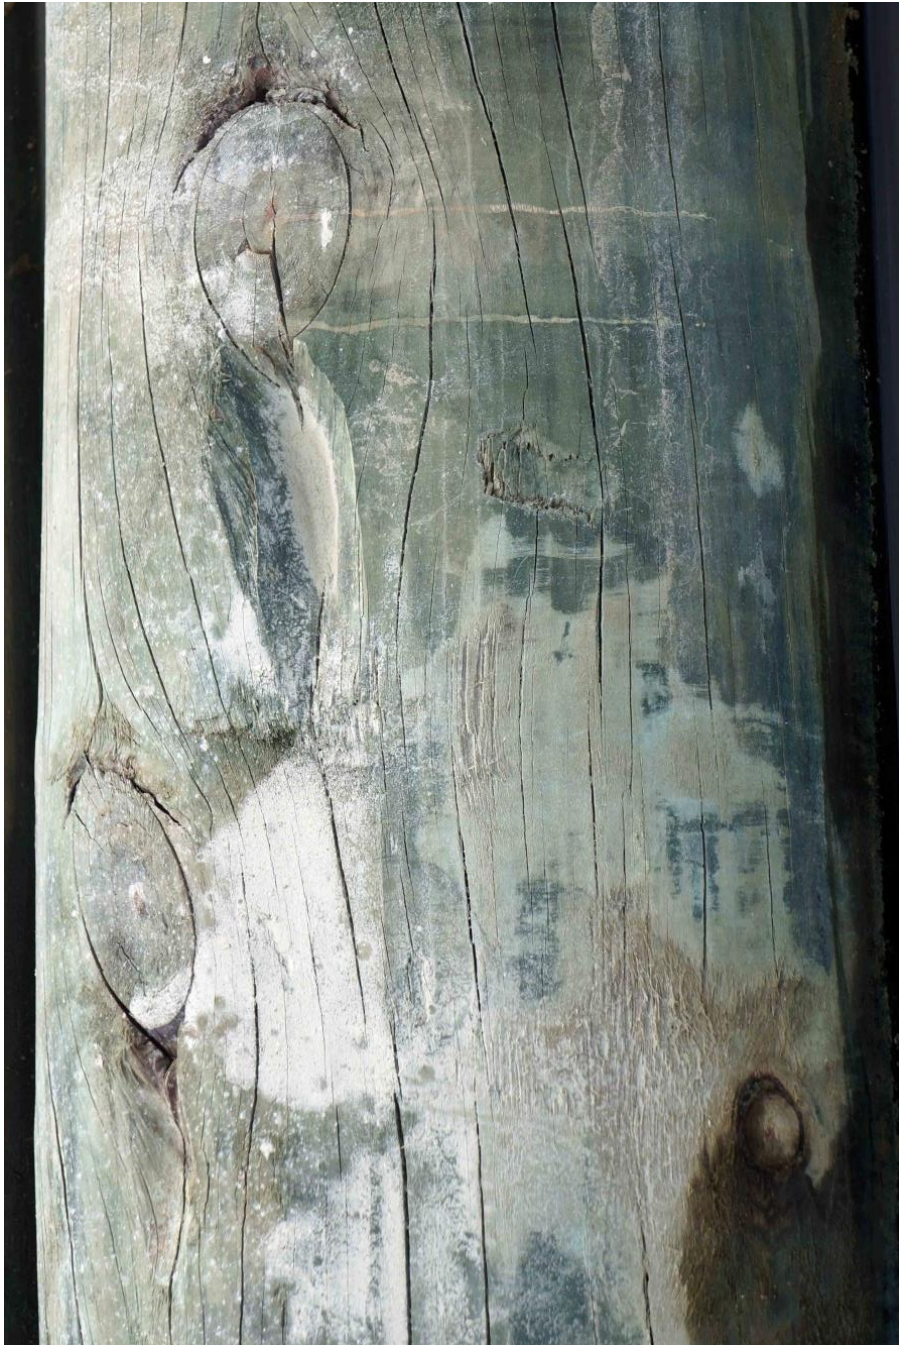
Figure 2: Typical of the 2nd grade piles widely used throughout Chaffers Marina

The use of 2nd grade low density *Pinus Radiata* timber piles in marine construction holds potentially serious and costly ramifications: where an abundance of knots and defects due to poor selection specifications and rough handling processes exist in piles, the timber becomes easily accessible to marine borer infestation.

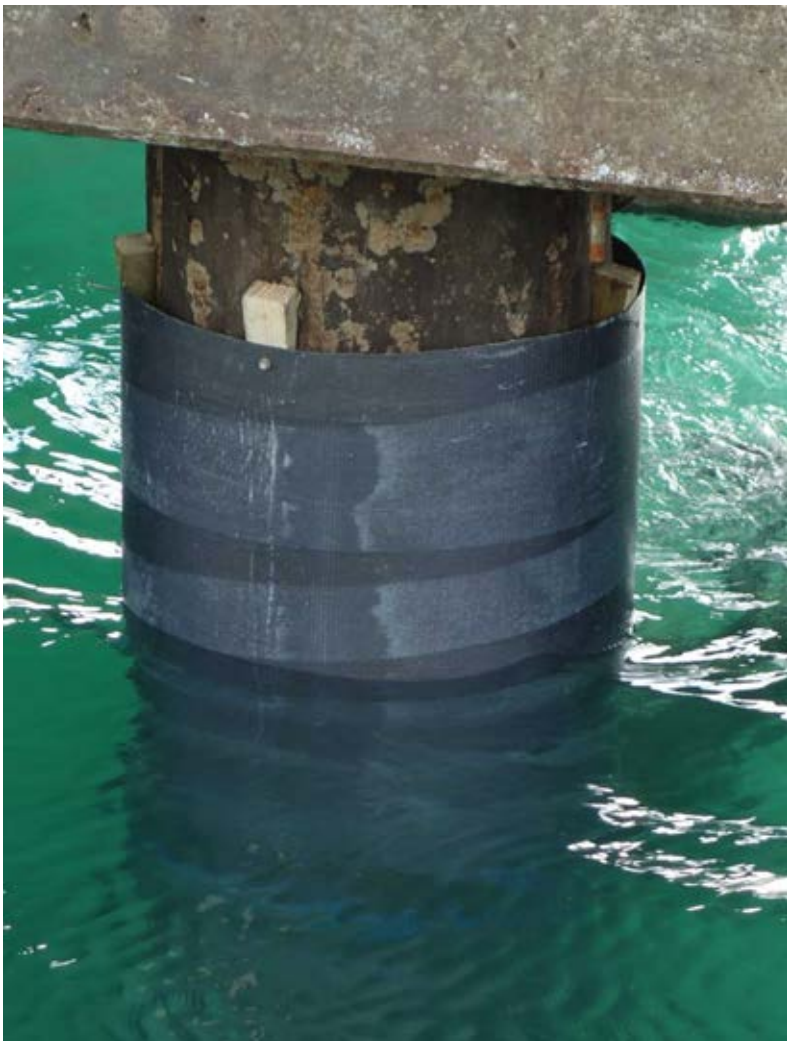
Figure 5: FRP jacketing of Boatlift structure timber pile

The seabed position was targeted as priority for timber pile rehabilitation by FRP process for piles within the berth areas; and at the Boatlift, timber pile deterioration was most prevalent and therefore a priority for FRP jacketing within the tidal zone.

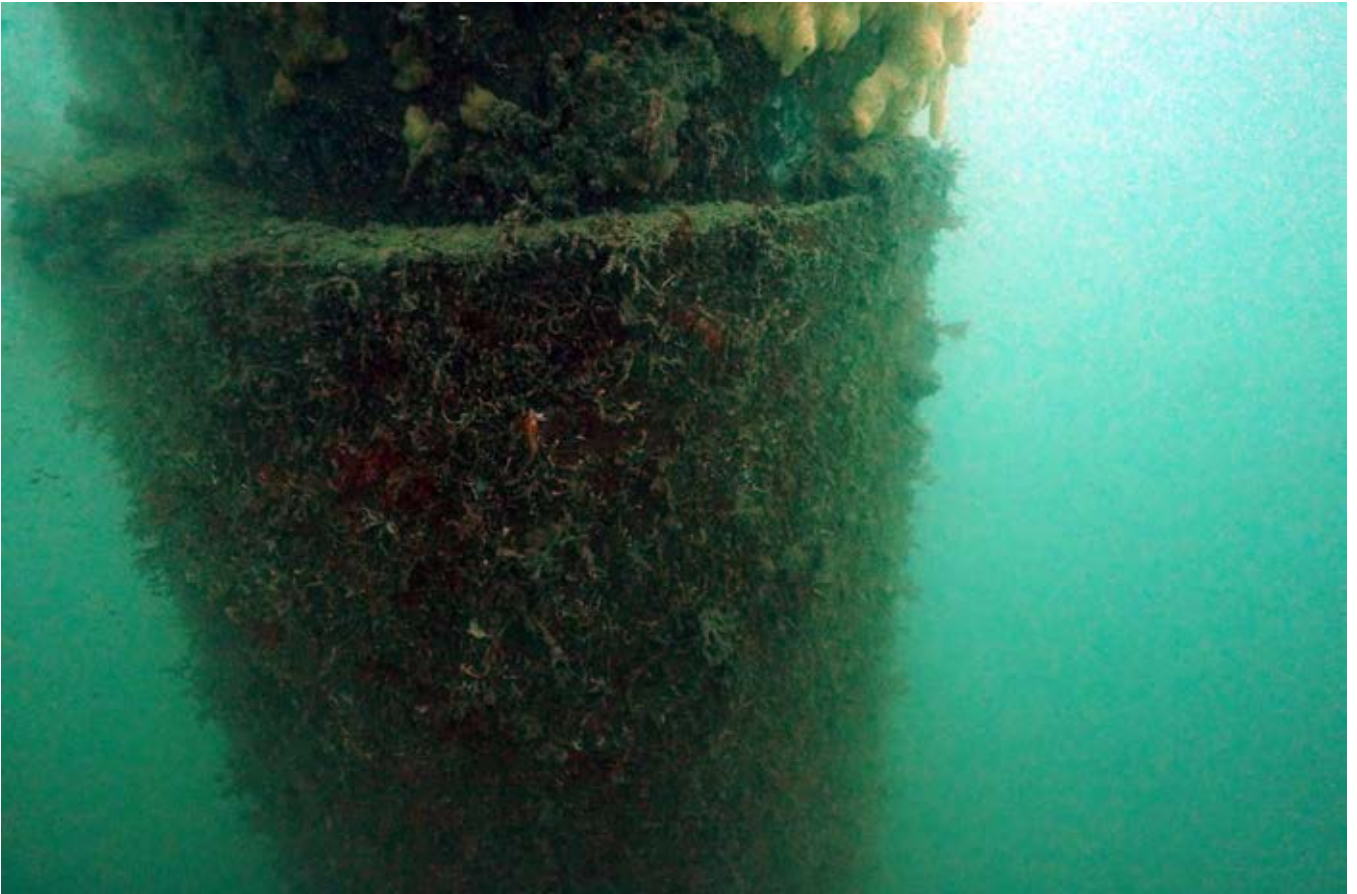
Figure 6: FRP jacketing of deteriorated timber pile – seabed installation – marina general berth position

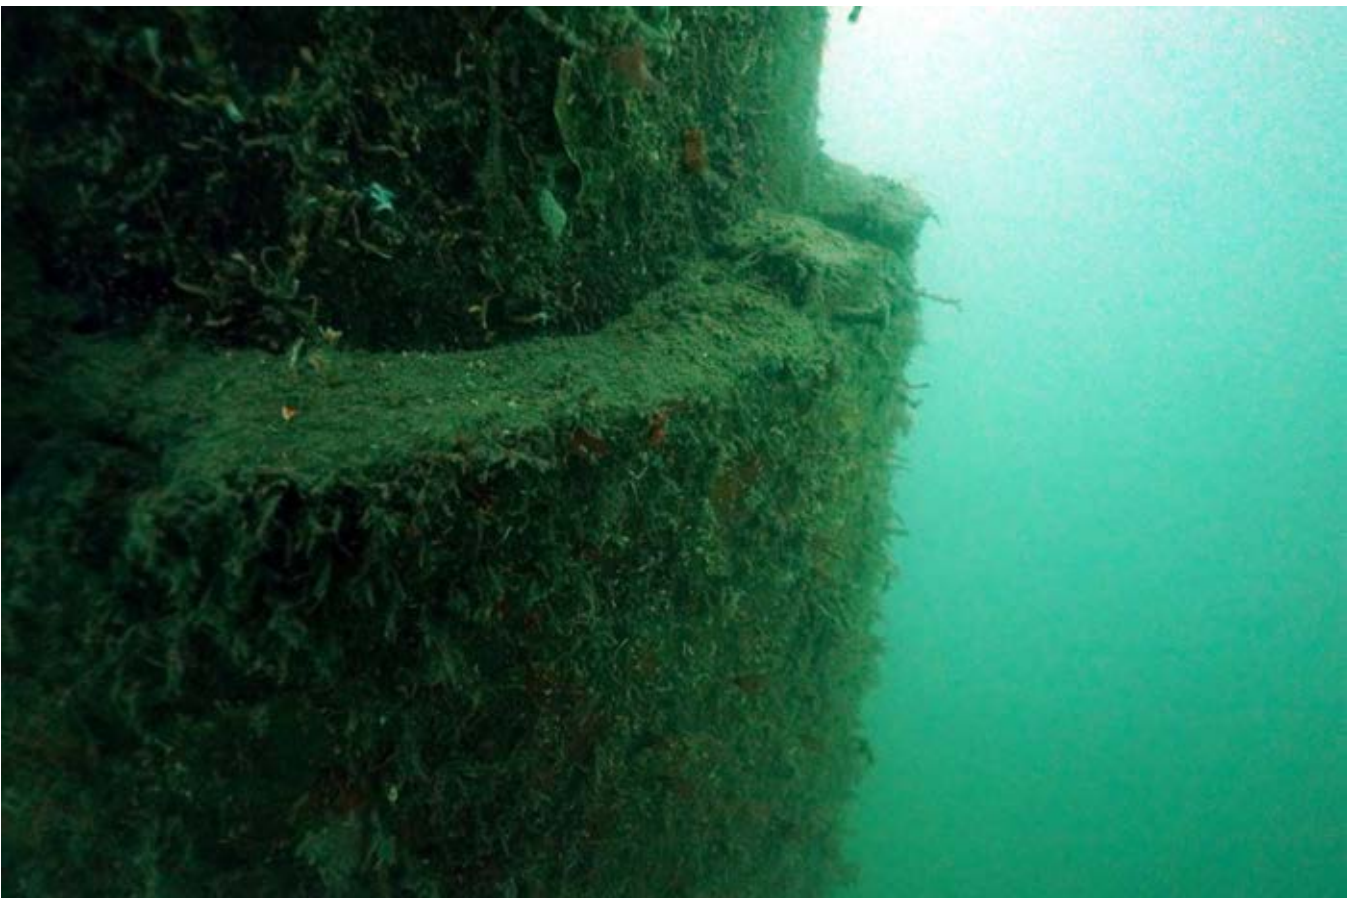
Figure 7: FRP jacketing of deteriorated timber pile – seabed installation – marina general berth position
